DEPARTMENT OF TRANSPORTATION

Contract #: 04-0120F4Cty: SF/ALA Rte: 80 PM: 13.2/13.9File #: 69.28**WELDING INSPECTION REPORT****Resident Engineer:**Siegenthaler, Peter**Address:** 333 Burma Road**City:** Oakland, CA 94607**Report No:** WIR-019111**Date Inspected:** 07-Jan-2011**Project Name:** SAS Superstructure**OSM Arrival Time:** 700**Prime Contractor:** American Bridge/Fluor Enterprises, a JV**OSM Departure Time:** 1900**Contractor:** Zhenhua Port Machinery Company, Ltd (ZPMC), Changxing Island **Location:** Shanghai, China**CWI Name:** Xu tao**CWI Present:** Yes No**Inspected CWI report:** Yes No N/A**Rod Oven in Use:** Yes No N/A**Electrode to specification:** Yes No N/A**Weld Procedures Followed:** Yes No N/A**Qualified Welders:** Yes No N/A**Verified Joint Fit-up:** Yes No N/A**Approved Drawings:** Yes No N/A**Approved WPS:** Yes No N/A**Delayed / Cancelled:** Yes No N/A**Bridge No:** 34-0006**Component:** OBG Components**Summary of Items Observed:**

WELDING INSPECTION REPORT

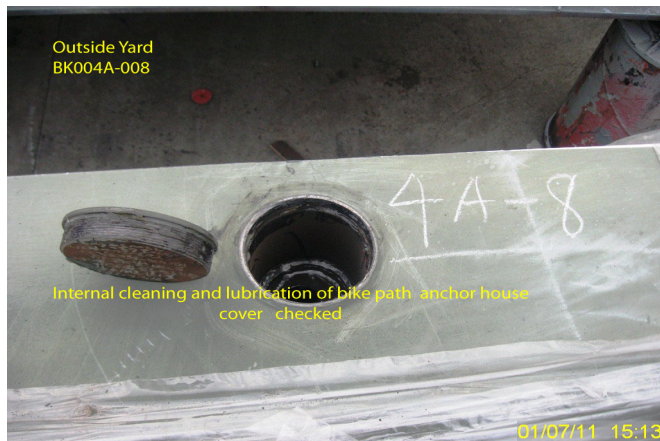
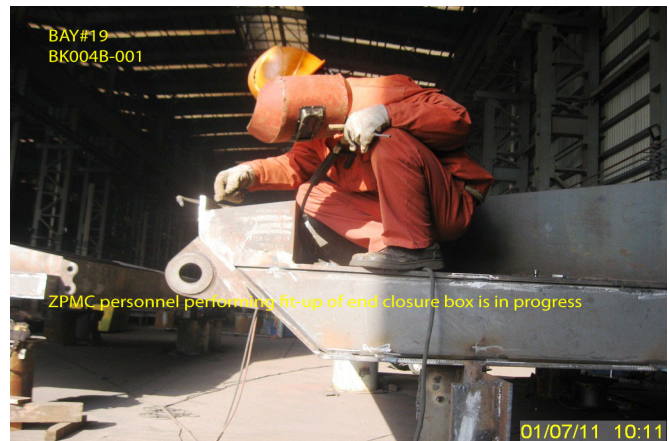
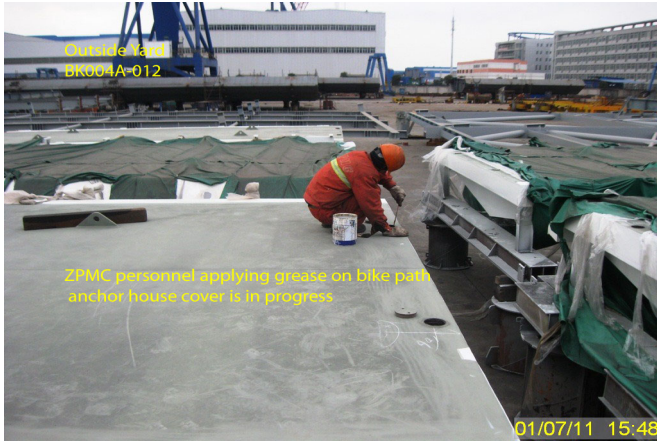
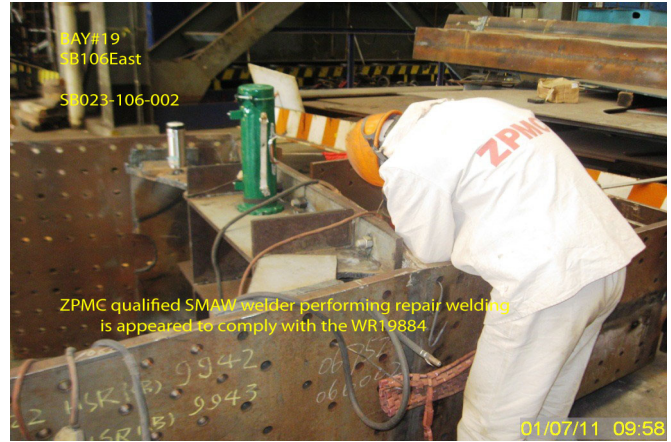
FCAW welding of critical repair (R3) weld is identified as 3G-005 of SB022-104 for SB104 West. The welder is identified as 058792. ZPMC QC is identified as Mr.Guo xing hui. The welding variables recorded by QC are appeared to comply with the WPS-345-FCAW-3G-ESAB-Repair and CWR-02693.

SMAW welding of repair (R2) weld is identified as 1G-002 of SB023-106 for SB106 East. The welder is identified as 067520. ZPMC QC is identified as Mr. Guo xing hui. The welding variables recorded by QC are appeared to comply with the WPS-345-SMAW-1G-Repair and WR-19884.

FCAW welding of weld is identified as 2G-007 of BK004B6-001 for BK004B-001. The welder is identified as 062806. ZPMC QC is identified as Mr.Guo xing hui. The welding variables recorded by QC are appeared to comply with the WPS-B-T-2232-ESAB.

FCAW welding of weld is identified as 3G-165 of BK005A6-002 for BK005A-002. The welder is identified as 062749. ZPMC QC is identified as Mr.Guo xing hui. The welding variables recorded by QC are appeared to comply with the WPS-B-T-2233-ESAB.

ZPMC personnel performing Fit-up of end closure box cover plate is in progress.

This QA inspector performed MT 15% base metal repair locations areas previously tested and accepted by ZPMC Quality Control personnel. This QA inspector generated an MT report for this date. The members are identified as OBG Bike path. The weld designations reviewed as follows.

This QA inspector performed internal cleaning and greasing on anchor house cover verified with ZPMC QC Mr.Xu tao is appeared to comply with the documents. The bike path is identified as BK004A-001,003,004,005,009,008,010,012.
BK006A-002.

Following bike paths the internal greasing was not applied properly informed to ZPMC QA Mr. Wang lu.
BK004A-020,021,053,054.
